## AN IDENTIFICATION OF LANDSLIDE POTENTIAL AREAS BY USING THE SHUTTLE RADAR TOPOGRAPHY MISSION (SRTM) IMAGES

This study aims to identify slope conditions along the shaft roads of Palopo-North Toraja using SRTM imagery related to landslide potential areas. The method used in identifying these areas comprises two approaches utilizing satellite imagery and field surveys. SRTM images are proposed to satellite imagery which was analyzed spatially by using the slope feature in the arctoolbox ArcGIS. On the other hand, field surveys were carried out by observing 19 location points which were used as observation stations in terms of recording coordinates and description of land cover, slope and landslide potential area. As the results, areas that experience cracks (landslide crawling) are founded from flat-slope to low-slope areas whereas medium-slope locations at 35,9% up to high-slope locations around 72,5% are landslides potential areas with the type of translation avalanche.

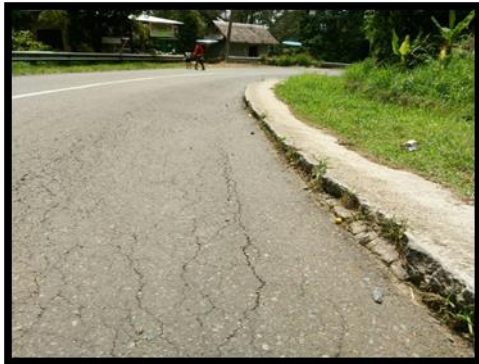
**Figure 2.** Ground cracks on the Palopo-North Toraja axis route

Symptoms for this can be observed in several locations ranging from ST02 to ST04.

This ground crack is one of land movement forms that can generate land slide namely land sediment. This sediment is one of landslide types where the gesticulation of this land moves slowly due to the ground types in this location consisting of coarse and fine grains. This ground movement is difficult to identify caused by its slow movement. After a long time, this landslide can cause some traffic signs along the road slope.

experience cracks (landslide creeping) come from a flat slope to a low slope while areas that meet landslides are from medium to high slope categories.

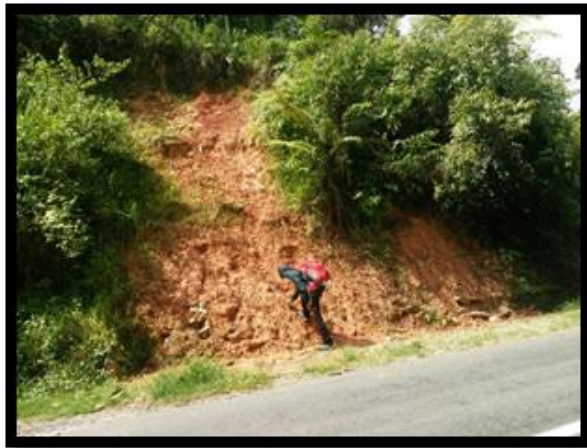
**Figure 3.** Translation avalanche in ST08

In addition, not only several locations that experienced land crawling, but also experienced the movement of land in terms of translation avalanches in several places precisely on the ST07, ST08 and ST09 observation stations. Translation avalanches are a type of avalanche that prevail due to the movement of a soil mass and rock in a flat or evenly sloping slope. This is also triggered by land cover which shapes bushes and rocky weathering.

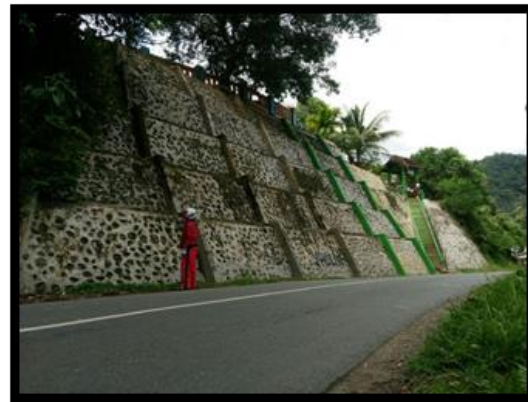
**Figure 4.** Building retaining walls in SDN 4 Mappatongko

West Wara Sub-District is one of the landslide prone areas. In this area, there are several landslides welcoming from the past. For this, along with this path a number of landslide mitigation measures have been made by the local government. Making this mitigation simplicity aims to repeat the risk of landslides. Some mitigation measures that have been taken include making gabions on the side of ex-excavated roads, making concrete on the side of the road to prevent creeping landslides, making retaining walls for buildings on the hill, and planting trees in roadside forests in Battang Village.
